Mtn View Aviation
An AP Enterprises, LLC Company
PO Box 31
Hubbard, OR 97032

MVA-177C10M&O
Installation and Maintenance Instructions for
Doot Steward[™]
In Accordance with STC SA01120SE

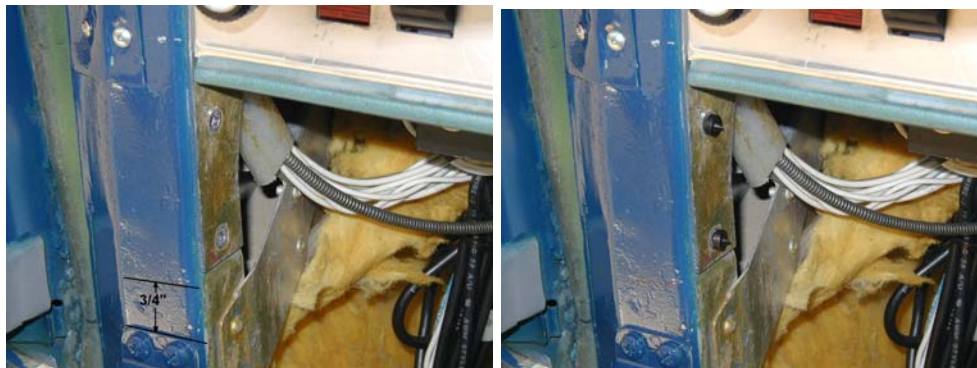
Picture 1. Shows a 3/4" mark made above the existing upper door stop bracket and both #5 existing rivets removed.

Picture 2. Shows the 5/32" blind hole spotters inserted into the empty holes.

5. Using a #21 Drill remove the two 5/32" rivets located behind where the inboard flange of the airframe bracket is to be mounted. (ref. Picture 1.)
6. Place a supplied 5/32" blind hole spotter in each of the removed rivet holes. (ref. Picture 2.) Position the airframe bracket into position, insuring the bracket is in full contact with the aft face of the door frame and transfer the hole locations to the airframe bracket by tapping with a small ball pein hammer on the bracket opposite the blind hole spotters location. Inspect the bracket to see that the blind hole spotters left a mark indicating the location to drill. The marked position for the #21 holes should be located diagonally aft and away from the predrilled #30 holes also located on this inboard flange. Drill the airframe bracket with the two #21 holes located.

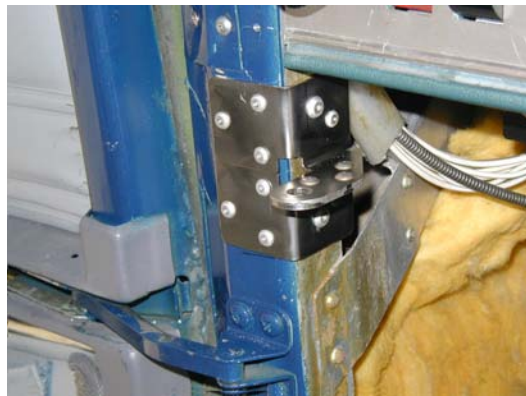
Picture 3.

12. Inspect the installation for security. (See Picture 3.)
13. Reinstall interior panels and modify as required to accommodate the new bracket.
13. Install the 5/16"-18 10mm Ball Stud (P/N MVA-9003) in the airframe bracket with the ball stud on top and a washer and the self locking nut on the bottom. Tighten to 80-90 in. lbs.
14. Remove the arm rest from the cabin door.
15. Locate the door bracket (P/N 177C102-1 L/H or 177C102-2 R/H) behind the arm rest and reinstall the arm rest with the door bracket between the door and the arm rest using the new 1 1/8" screws supplied with the kit. The door bracket hole for the ball stud is slotted to allow setting the full open position within the range of the slot.

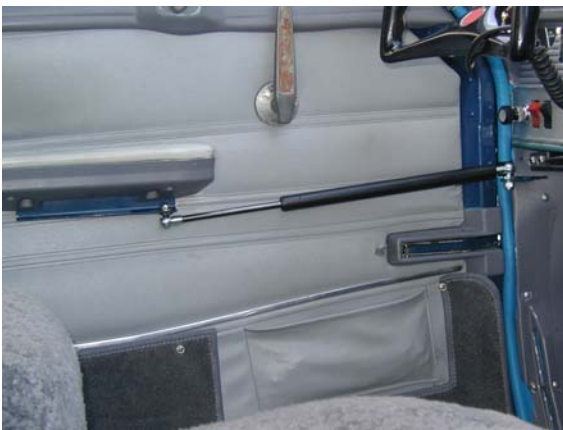
Picture 4.
Installation Complete Door Closed

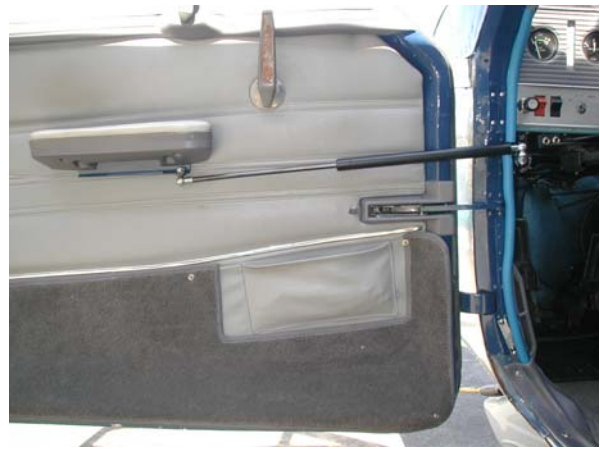
Picture 5.
Installation Complete Door Open
