*Mtn View Aviation*  
An AP Enterprises, LLC Company  
PO Box 31  
Hubbard, OR 97032

MVA-200C10M&O  
Installation and Maintenance Instructions for  
*Doot Steward*<sup>™</sup>  
In Accordance with STC SA01120SE

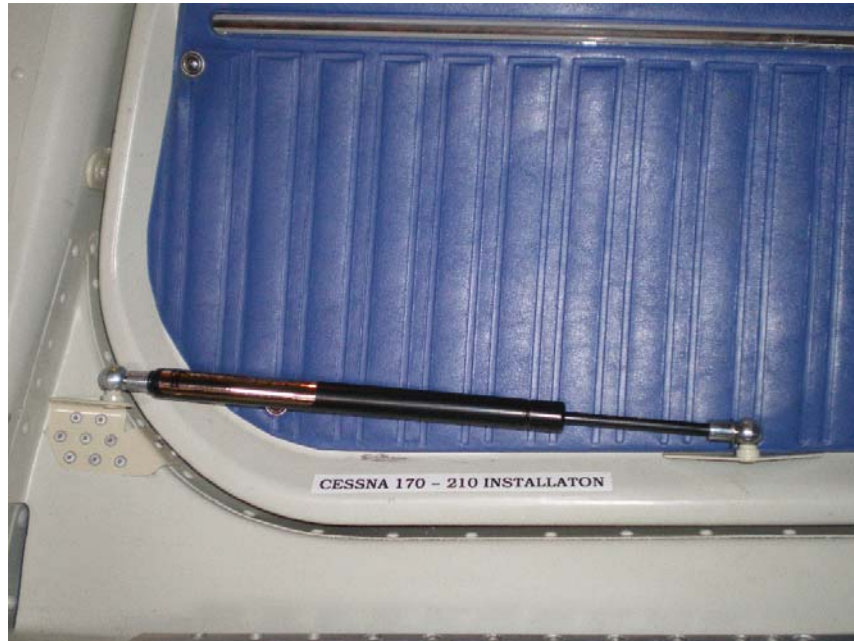
Picture 1.

The completed installation must have the tube end of the gas spring slightly higher than the rod end so that seal lubrication is maintained on the end seal. If the gas spring is installed level, the end seal may not maintain lubrication and could result in a gradual loss of pressure in the gas spring. (Refer to picture 1.)

(Note the airframe attach point is slightly higher than the door attach point.)

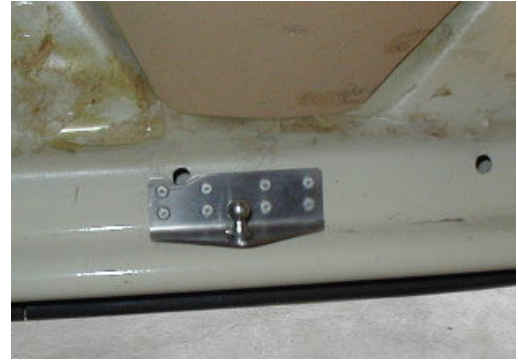
Picture 2.

If the door bracket is located toward the airframe bracket, the gas spring will try to extend the door further than the fully open position used to mark the door bracket. If you intend to retain the original aircraft door stops, this is not a problem. If using the *Door Steward*<sup>™</sup> to limit the door opening, insure it will not contact or damage any other structure such as the wing strut. Also the gas spring maybe put in a bind up against the door if located too close to the airframe bracket. Double check your intended location of the door bracket while attached to the gas spring to insure none of these problems will occur.

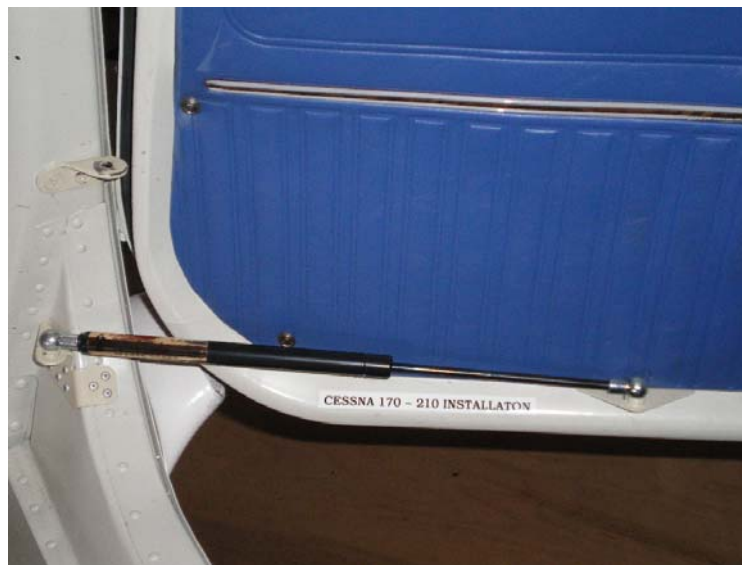
Picture 3.

20. Reinstall the interior door panel. If you used the extended door bracket, install the threaded ball stud, nut and washer after the interior panel that you slotted covers the door bracket.
21. Install the tube end of the gas spring on the airframe bracket and install the rod end of the gas spring on the door bracket. Insure any locking devices or safety clips are installed to securely lock the gas spring in place.

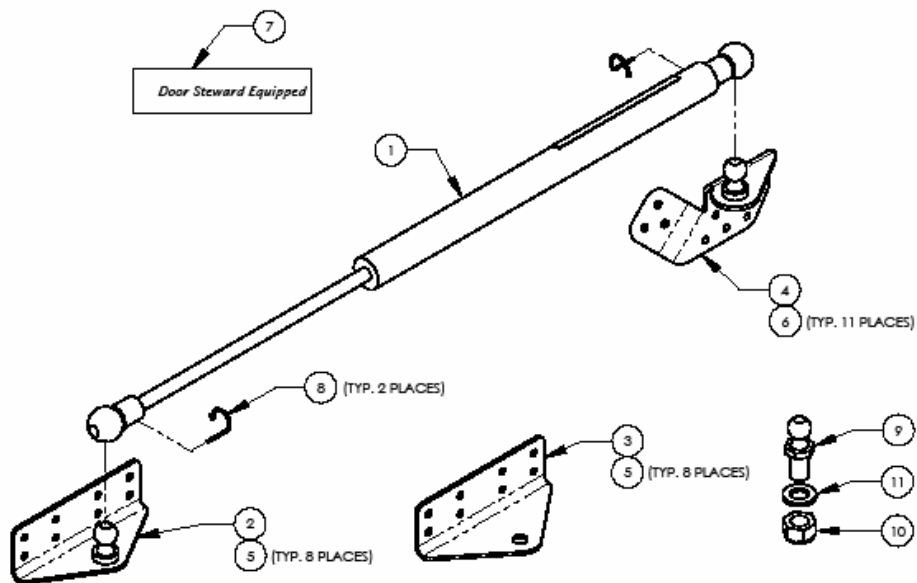
Item No.	Part Number	Description	Qty Reqd
	200C10-1	Installation Assembly, LH	Ref.
	200C10-2	Installation Assembly, RH	Ref.
1	. 201C101-1	Gas Spring Assembly	1
	. . 201C101-002	Gas Spring, Chrome or Nitrided Rod	1
	. . MVA-9001	End Fitting, All Steel	2
	. . MVA-200	Identification Label	1
2	. 201C103-1	Bracket Assembly, Door	1
3	. 201C104-2	Bracket, Door, Alternate and/or option	1
4	. 201C105-1	Bracket Assembly, Airframe, LH	1
	. 201C105-2	Bracket Assembly, Airframe, RH	1
5	. CR3213 4-2	Rivets, Blind	16
6	. CR3213 4-3	Rivets, Blind	11
7	. MVA-201	Decal, Door Steward Equipped	1
8	. MVA-9002-01	Safety Clip	2
9	. MVA-9004-01	Ball Stud, 10mm, 1/4-20 Threads	1
10	. MVA-9005-4	Locknut, Thin, 1/4-20	1
11	. NAS1149F0463P	Washer	1
