*Mtn View Aviation, LLC.*  
921 SE 47<sup>th</sup> Ave., Suite 2  
Portland, OR 97215

MVA-200C10M&O  
Installation and Maintenance Instructions for  
*Door Steward*<sup>™</sup>  
In Accordance with STC SA01120SE

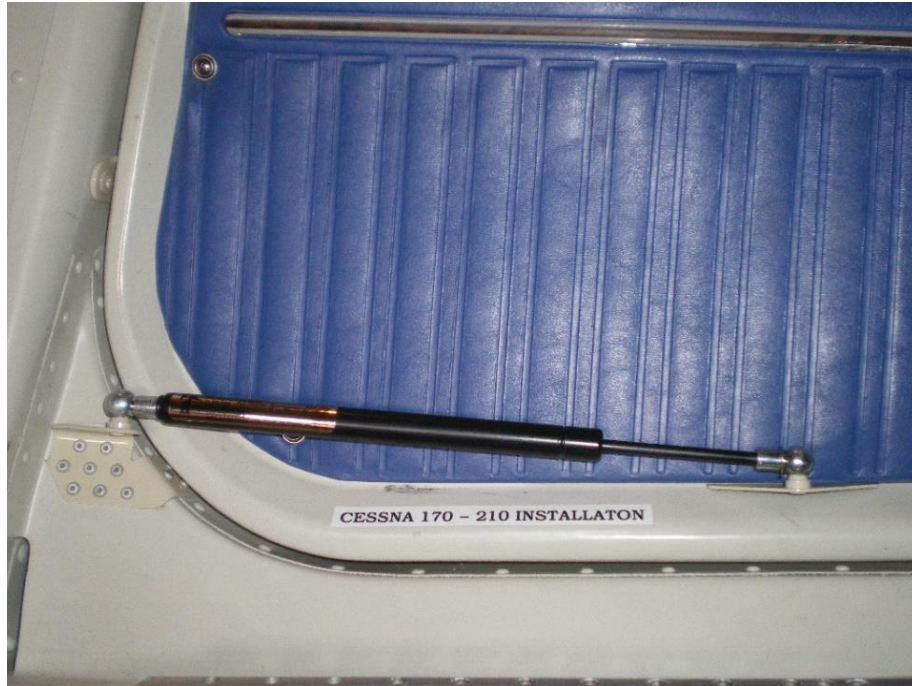
**Figure 1**

The completed installation must have the tube end of the gas spring slightly higher than the rod end so that seal lubrication is maintained on the end seal. If the gas spring is installed level, the end seal may not maintain lubrication and could result in a gradual loss of pressure in the gas spring. (Refer to Figure 1.)

(Note the airframe attach point is slightly higher than the door attach point.)

7. Locate the airframe bracket assembly, P/N 201C105-1, L/H or P/N 201C105-2, R/H onto the lower door sill and adjacent structure so that the ball stud on the bracket will be slightly higher than the intended location of the ball stud on the door bracket. The airframe bracket may need to be bent slightly to insure the bracket conforms as close as possible on both surfaces.

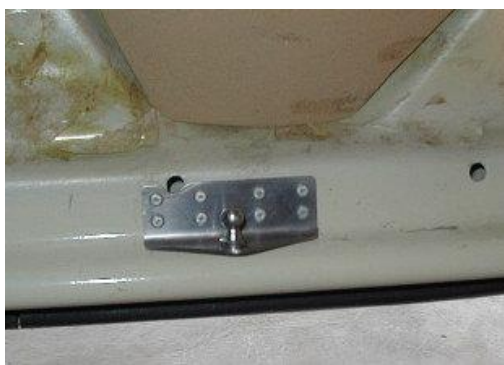
**Figure 2**

15. With the gas spring fully extended and the aircraft door at the desired full open position, (Typically  $\frac{1}{4}$ " –  $\frac{1}{2}$ " gap between the bottom of the door and the wing strut.) mark the location of the door bracket on the door. On models with no wing strut, make sure the door bracket location provides for at least 9.5 inches of distance from ball stud to ball stud with the door closed. Any less distance and the gas spring will bottom out before the door is completely closed. Insure it is located low enough so the bottom of the bracket will just clear the bottom of any interior door panel. (Unless using the extended door bracket and you plan to slot the interior panel) Also check for the contact between the door and the gas spring when in your intended full open position. The gas spring can have slight contact with the door but avoid causing heavy contact with the door. Take into consideration any interior that may be reinstalled between the door and the gas spring.

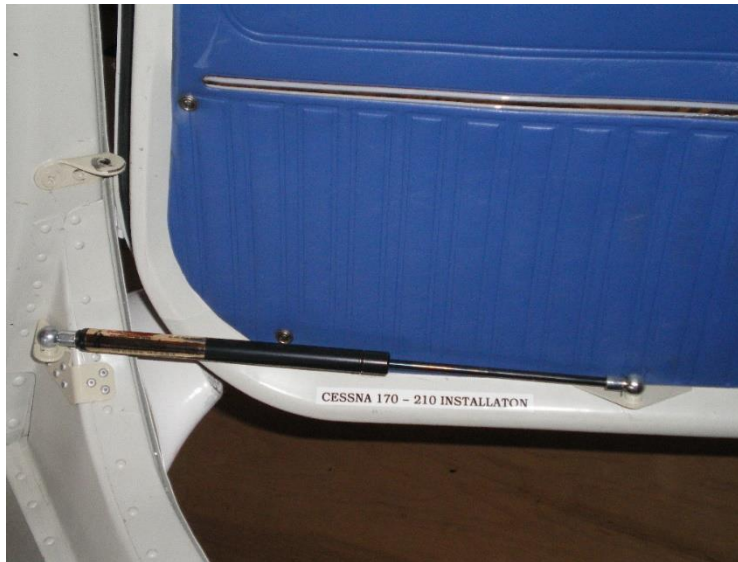
**Figure 3**

23. Install the tube end of the gas spring on the airframe bracket and install the rod end of the gas spring on the door bracket. Insure any locking devices or safety clips are installed to securely lock the gas spring in place.
